# Crack detection in churches using deep learning

Matteo Bozzano<sup>1</sup> · Mohamedelmustafa Omer Eid<sup>2,3</sup> · Serena Cattari<sup>1</sup> · Bianca Federici<sup>1</sup>

Received: 28 February 2026 / Accepted: 14 May 2026 / Published online: 26 May 2026  
© The Author(s) 2026

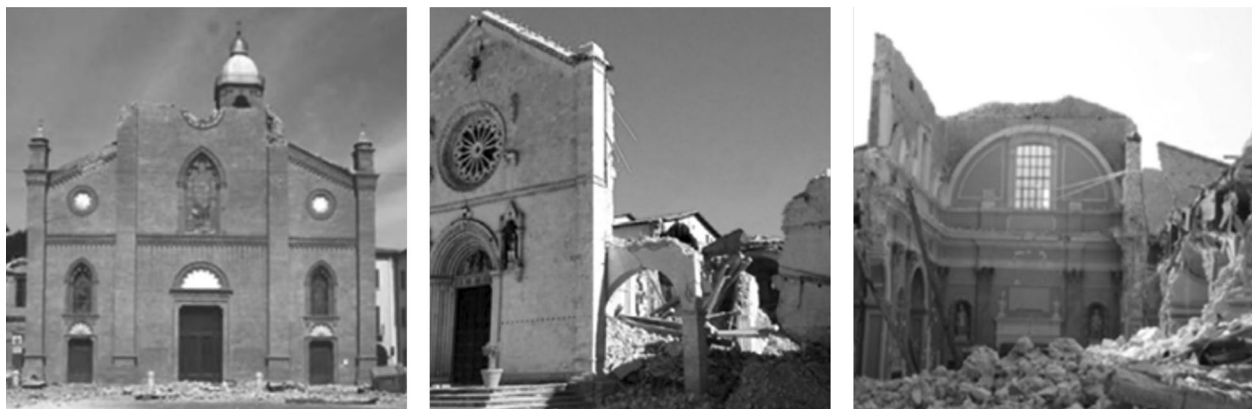
**Fig. 1** Example of damage that occurred to churches hit by past earthquakes: **a)** St. Maria Maggiore Church in Mirandola (Emilian earthquake, 2012); **b)** St. Maria Paganica Church (L'Aquila earthquake, 2009); **c)** St. Benedetto di Norcia (Norcia earthquake, 2016/2017)

(Guerreiro et al. 2000; Lagomarsino 2012; Sorrentino et al. 2014; Penna et al. 2019), as shown in Fig. 1.

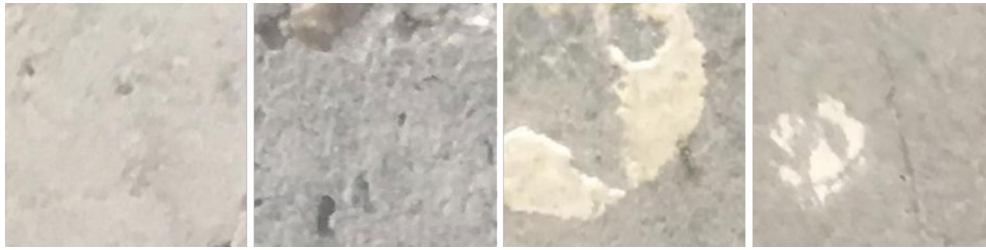
**Fig. 5** Negative crack images from Concrete Crack Images for Classification dataset (Özgenel 2019)

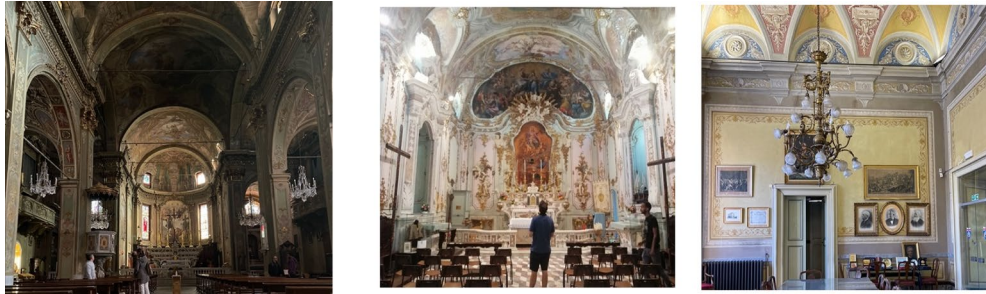
**Fig. 6** Sites of the first in-situ surveys: the San Francesco d'Albaro church (on the left), the Oratory of Nostra Signora Assunta in Genova Coronata (in the middle) and the meeting room of the Dean of the

Polytechnic School at the University of Genova, in Villa Giustiniani Cambiaso (on the right)

to survey the walls and vaults of the meeting room of the Dean of the Polytechnic School at Villa Giustiniani Cambiaso, the Nostra Signora Assunta Oratory in Genova Coronata, and the San Francesco d'Albaro Church (Fig. 6). All three buildings are located within the municipality of Genova. A second round of surveys took place in January 2024 in the churches of San Giovanni Battista in Aggio, San Giovanni Decollato in Montoggio, and Nostra Signora delle Grazie in Vobbia (Fig. 7). Aggio is a district within the municipality of Genova, while Montoggio and Vobbia are small municipalities in the province of Genova. The churches were selected with the assistance of the Genoese Curia, based on their diverse floor plan typologies and the presence of cracks on vaults and/or walls. A sketch outlining the layout of the three churches is shown in Fig. 8. For this second round of surveys, the same instruments were used. They are visible in Fig. 9.

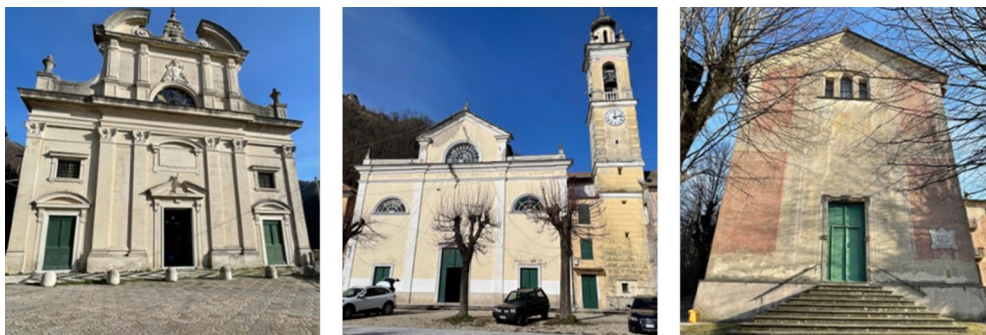
**Fig. 7** Sites of the second in-situ surveys: Aggio (on the left), Montoggio (in the middle) and Vobbia (on the right) churches

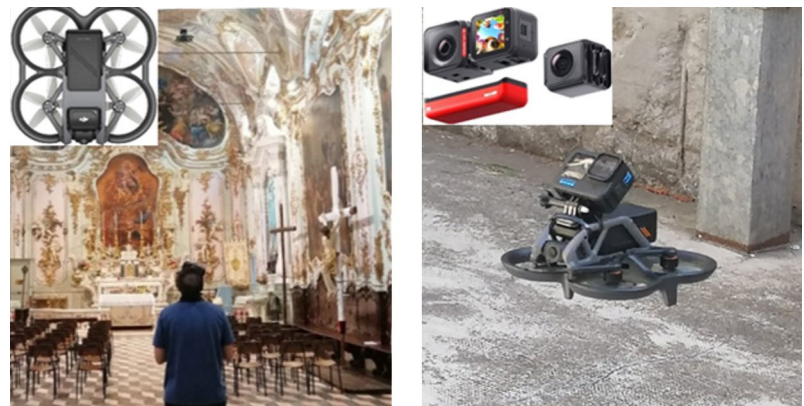
**Fig. 9** Used instruments: a DJI Avata drone equipped with an Insta360 spherical camera

The spherical camera was chosen for its ability to capture both side walls and the ceiling in a single flight. This capability is especially advantageous in post-earthquake assessments, where rapid data collection and operational efficiency are critical for damage evaluation and recovery planning. The 360-degree field of view provided by the camera minimizes the need for multiple passes, thereby accelerating structural assessments and enhancing workflow efficiency. From these surveys, a set of images was obtained, from which the best-quality images were selected. Prior to training, the images were converted to grayscale. These images were then divided into 1,858 patches, each measuring 227x227 pixels. Of the resulting dataset, 75% was allocated for training, while the remaining 25% was used for model validation. Within this training set, 539 patches were labeled as "crack" and 854 as "non-crack." This disparity ensures adherence to a maximum 1:3 ratio between crack and non-crack patches, which is essential for preventing model bias (Fan et al. 2018). The validation set was split into 180 patches labeled as "crack" and 285 as "non-crack."

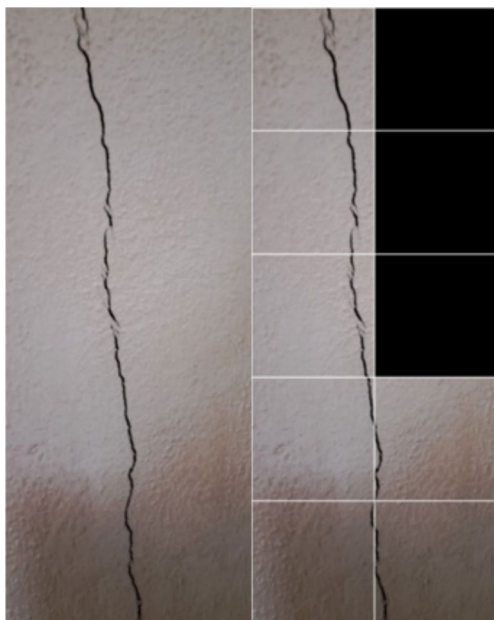
**Fig. 15** Concrete image (on the left) and the corresponding image classified in crack patches and non-crack one, the latter represented in black (on the right)

An example of a crack identified by the model in a concrete image is shown in Fig. 15. The single patches are rearranged, indicating the location of the crack in the image.

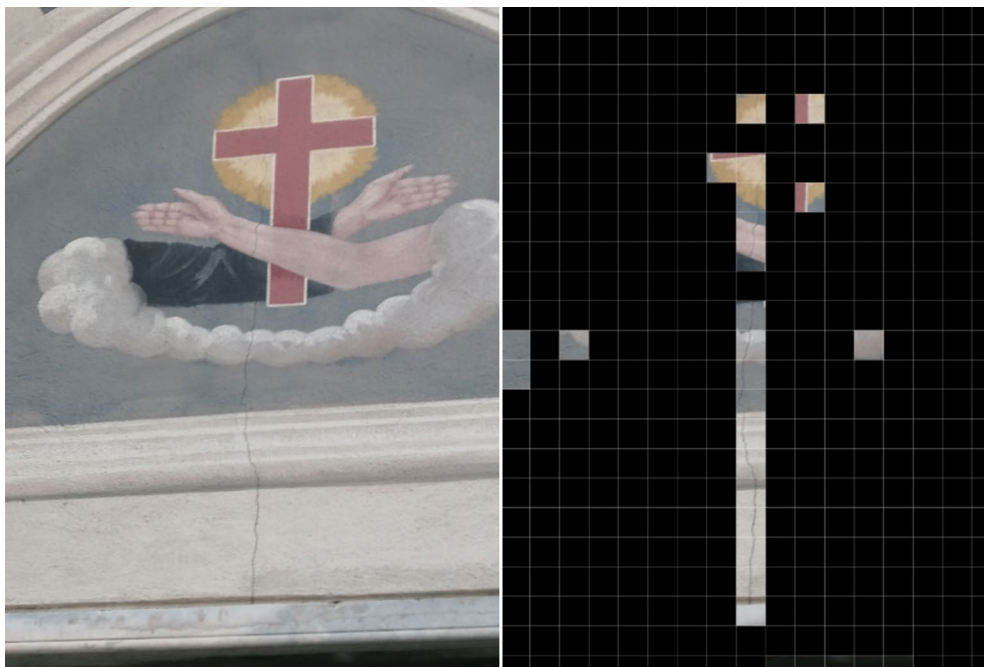
**Fig. 19** Image of a decorated wall (on the left) and the corresponding image classified in crack patches and non-crack one, the latter represented in black (on the right)

Figure 19 shows the model’s ability to detect cracks on a decorated wall. In fact, most of the patches characterized by cracks are highlighted in the image.

The final output consists of a binary spatial map of crack/non-crack patches overlaid on the original image (right image in Fig. 19). When integrated within a photogrammetric pipeline, the binary patch map can be overlaid onto geo-referenced orthophotos of the surveyed surfaces, enabling approximate spatial localization of crack-affected regions in metric coordinates.

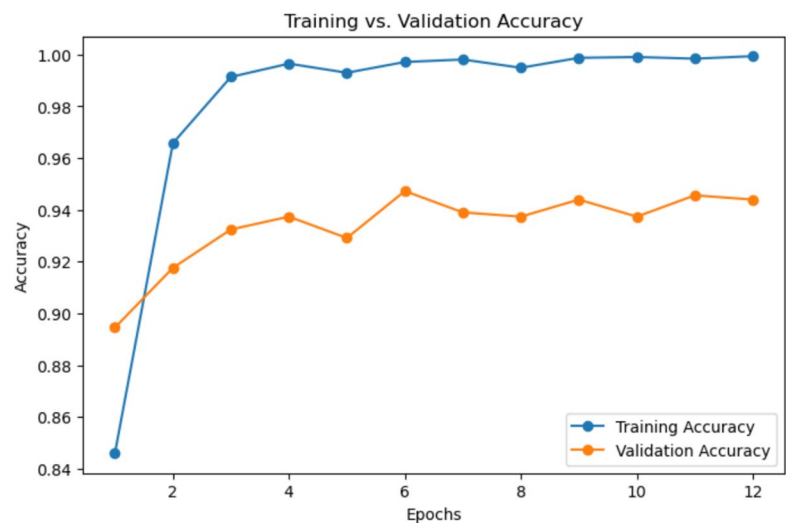
**Fig. 20** Training and validation accuracy of the trained on decorated images model
